BUTLER BAY/CREQUE DAM WATERSHED CHARACTERIZATION SUMMARY

August 2025 DRAFT

Prepared by:

Horsley Witten Group, Inc.

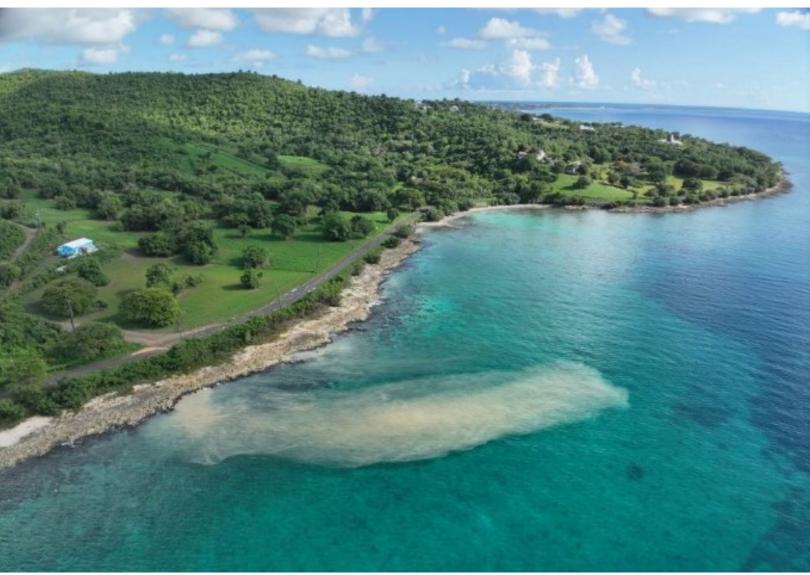
Sediment plume in Butler Bay, likely resulting from steep dirt roads and inadequate drainage design (Ceiba Strategies)

Sediment plumes have been observed near coral restoration sites in Butler Bay. The frequency, duration, and magnitude of sedimentation events in Butler Bay have not been measured but have been attributed to unpaved road erosion by local stakeholders. Sedimentation is known to negatively affect coral reefs by smothering coral tissue, reducing light availability, and impairing growth and reproduction.

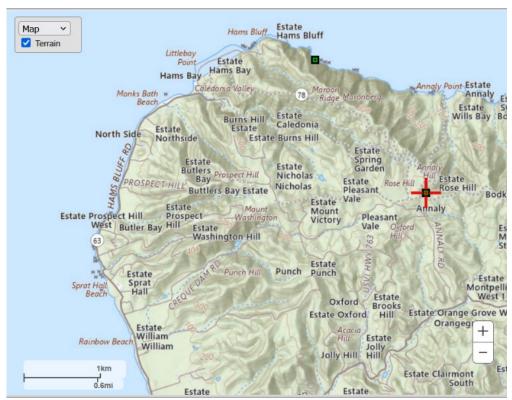
Figure 3. Location of NOAA PFD precipitation stations closest to the Butler Bay Watershed. Previous hydrologic studies for Creque Dam Gut used Annaly rainfall.

Table 2 summarizes the 24-hr rainfall amounts for standard storm frequencies from <u>NOAA Atlas</u> <u>14</u>, Vol 5, Version 3 at the two nearest stations (**Figure 3**). Stormwater standards for the USVI suggest use of the Atlas 14+ method for stormwater sizing calculations.

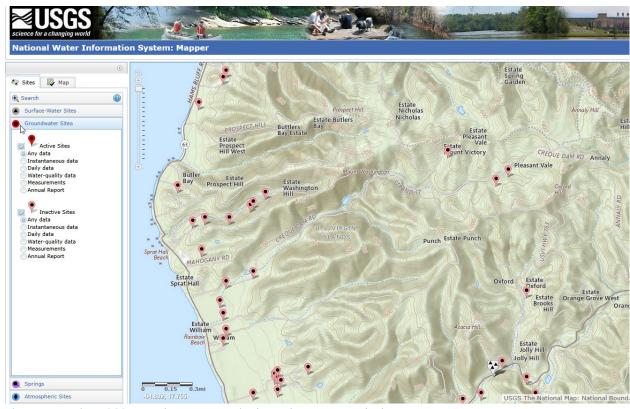
Figure 4. Inactive USGS groundwater gauges in the Butler Bay Watershed

There are no active <u>USGS stream gauges</u> in the Butler Bay Watershed, but there are several inactive groundwater wells (**Figure 4**). The closet active groundwater well is to the south in Estate Prosperity ("Mahogany Road 4 Well"), while the closest active surface water site is to the southeast ("Gut 4.5 at Cane Valley").

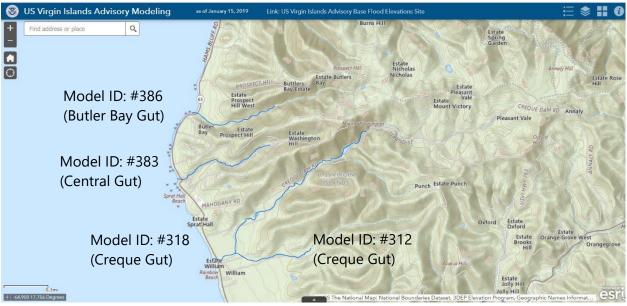
Figure 5. Guts studied by FEMA after 2017 hurricanes

Following the 2017 hurricanes, the Federal Emergency Management Agency (FEMA) conducted additional hydrologic and hydraulic analyses in the USVI, including in the Butler Bay Watershed (FEMA, 2018). Modeled discharge rates for four streams in Butler Bay are shown in **Figure 5** and summarized in **Table 3**.

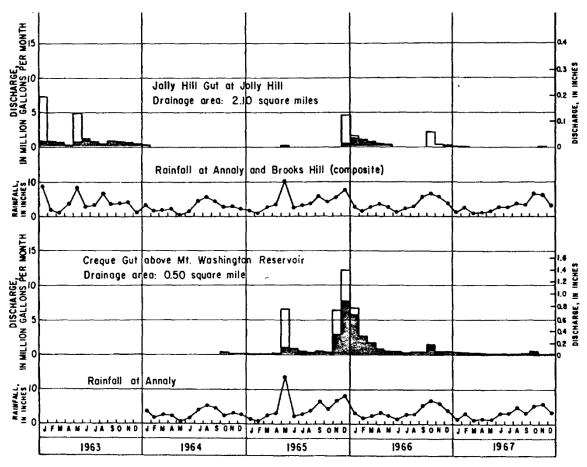
Figure 6. Monthly stream flow above Creque Dam and rainfall at Annaly 1963-1967 (Jordan, 1975)

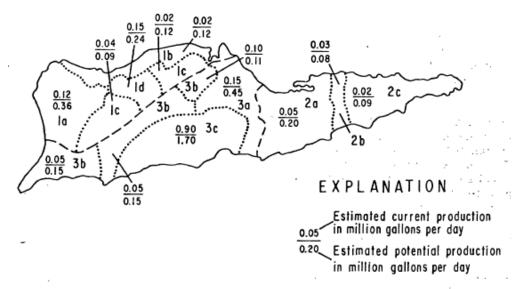
Figure 7. Estimated current production and potential yield from groundwater areas in 1967 (Jordan, 1975)

- The study estimated a potential groundwater yield of roughly 360,000 gallons per day for an average effective recharge of roughly 0.8 inch annually.
- The mouth of Creque Gut could yield ~ 60,000 gpd (100,000 gpd at Jolly Hill), with a potential to yield 70,000 gpd through development of mountain basins, reducing stream

base flow but not negatively affecting coastal plain recharge. It also noted that 30,000 gpd could be added to the potential yield through artificial recharge of water from the Creque Dam reservoir.

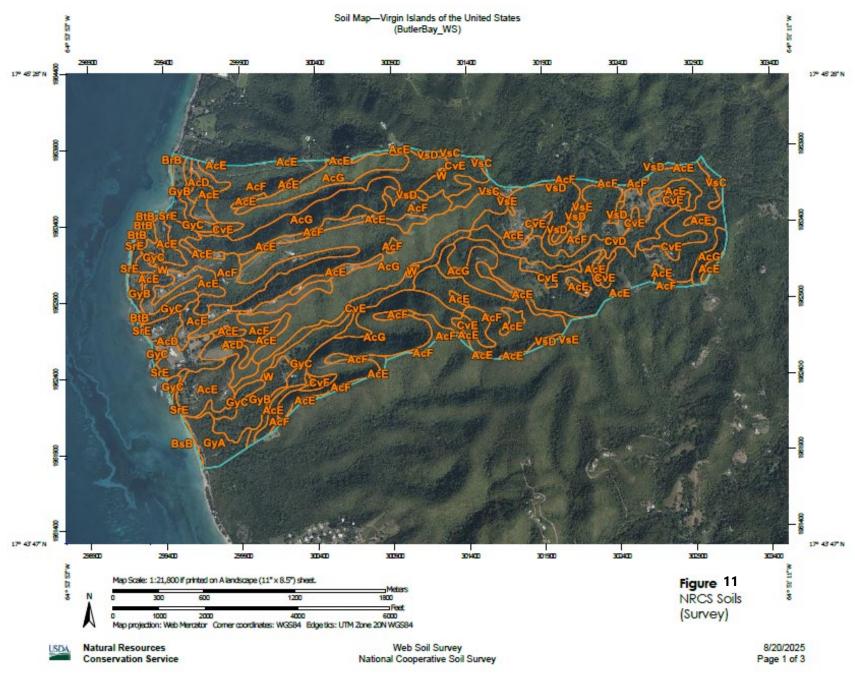
Figure 11. NRCS web soil survey excerpt for Butler Bay

The U.S. Department of Agriculture Natural Resources Conservation Service (NRCS) provides soil information on type (**Table 5**), hydrologic soil group (**Table 6**), erodibility, and landslide potential. Geologically, most of the watershed is comprised of weathered volcanic bedrock. An excerpt from the online soils report is provided in **Figure 11**.

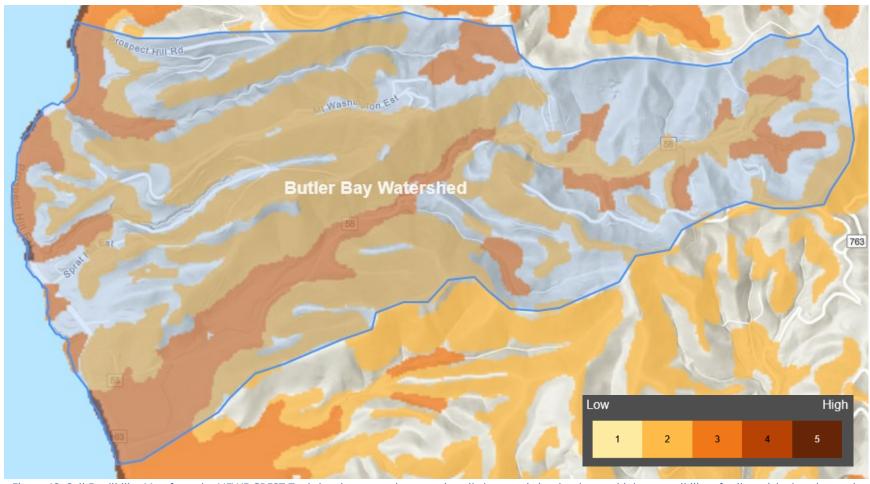
Figure 13. Soil Erodibility Map from the NFWF CREST Tool showing areas that contain soil characteristics that have a high susceptibility of soil particle detachment by water. This may include areas that have high silt content or migratory systems such as beaches and dunes. High values suggest that areas carry an increased potential for erosion due to flooding or heavy precipitation events. https://resilientcoasts.org/AnalyzeProjectSites.

Much of the watershed is characterized as "highly erodible" (**Figure 13**) and some of the watershed is susceptible to potential landslides, especially in the middle section of the watershed (**Figure 14**).

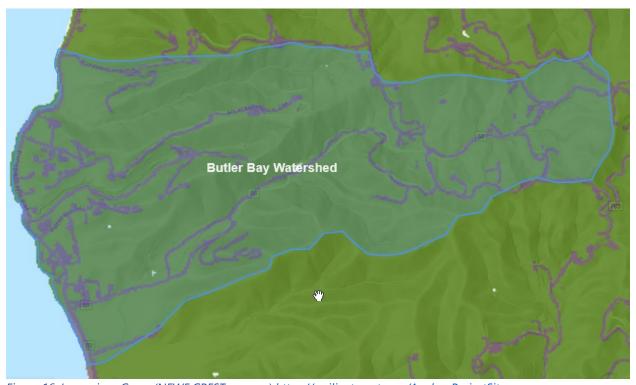
Figure 16. Impervious Cover (NFWF CREST mapper) https://resilientcoasts.org/AnalyzeProjectSites

Guannel (2018) represents the most recent landcover mapping information (**Figure 17**). The vast majority of the watershed is characterized as Forest, with areas of Developed Medium Intensity and Developed Low Intensity in the lower (i.e., western) portion of the watershed (**Table 9**). Pockets of Shrub and Developed Open Space are also present, especially around development in the lower watershed. This landcover dataset may underrepresent agricultural uses in the watershed. The watershed has less than 3% impervious cover (33.5 acres) based on the CREST analysis (see **Figure 16**), which is an indicator of generally high quality watershed health.

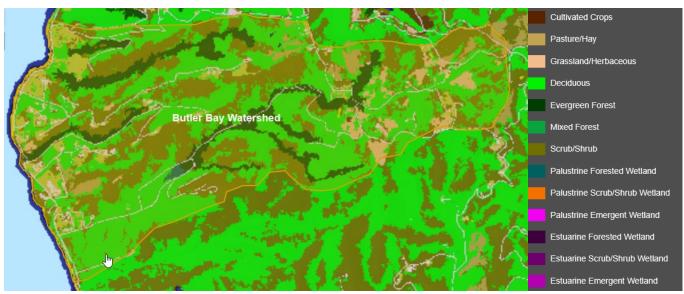
Figure 21. CCAP Data provides a breakdown of vegetative cover type for terrestrial and wetland areas. 49% of area is deciduous forest, 32% is scrub/shrub, 9% Evergreen forest, 5% urbanized, 3% grassland/herbaceous, and 2% hay. From the NFWF CREST mapping tool https://resilientcoasts.org/AnalyzeProjectSites.

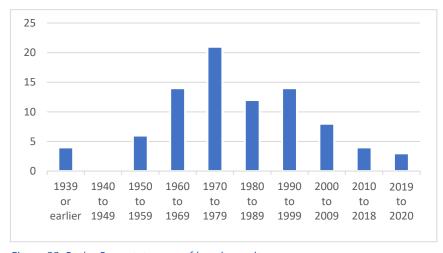
Figure 22. Butler Bay estates age of housing units

Of these 86 housing units, more than half of the structures were built before 1980 (**Figure 22**) (U.S. Census Bureau, 2020). Older OSDS may have less effective treatment technology and/or in need of maintenance and upgrades

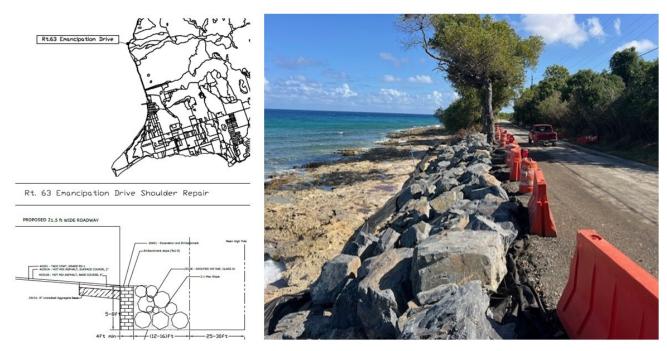
Shoreline and road stabilization project along USVI Highway 63/Emancipation Drive completed by DPW in 2025

DPW recently completed a shoreline and road stabilization project along approximately 300 linear feet of USVI Highway 63/Emancipation Dr., located within the Butler Bay Watershed (image below). According to communications with DPW, no additional infrastructure upgrades are currently proposed within the watershed (Piotr Gajewski, pers. com., 2025). Local residents have inquired about potential infrastructure upgrades, especially on roads, and reached out to engineering firms about solutions and to DPNR about funding.

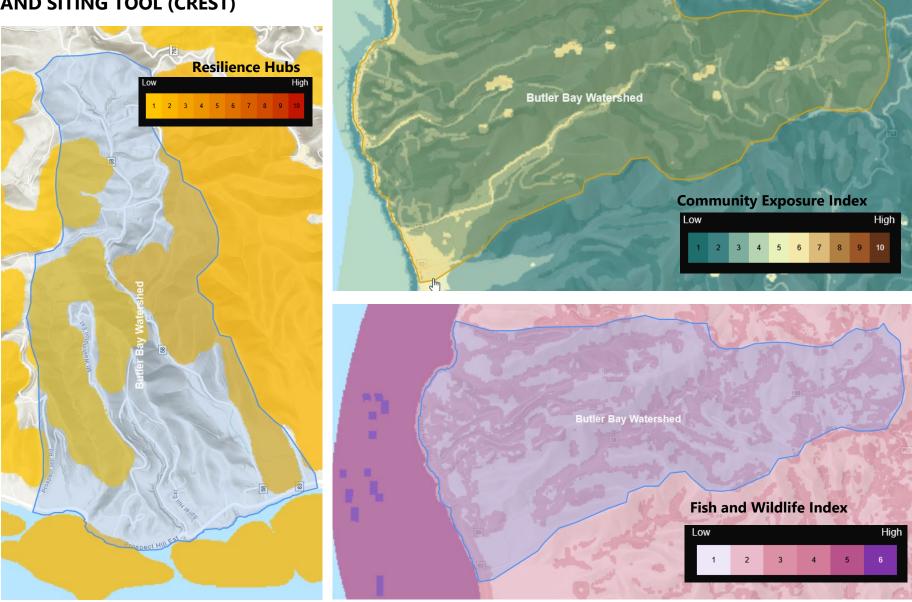
Figure 23. Results of CREST analysis overlaid onto Butler Bay Watershed

The National Fish and Wildlife Foundation (NFWF) and the National Oceanic and Atmospheric Administration (NOAA) coordinated to fund the U.S. Virgin Island Coastal Resilience Assessment. This GIS-based analysis combines spatial data related to land use protected areas, human community assets, flooding threats, and fish and wildlife resources in order to identify and prioritize Resilience Hubs (**Table 19, Figure 23**). The purpose is to identify areas where the implementation of nature-based features could maximize community resilience and wildlife benefits.

Fish and Wildlife Index	Identifies valuable habitat for species of concern in both the terrestrial and marine environments. Higher values indicate more valuable habitat areas for both. Parameter values range from 0-6.	2.5	0-6
Marine Index	Higher values identify habitat areas that are most valuable for providing protection to nearby coastal communities and marine species.	2	0-4
Terrestrial Index	Higher values identify habitat areas that are suitable to the most species of concern for that region, based on habitat preferences and potential threats identified by the IUCN Red List.	1.5	0-4

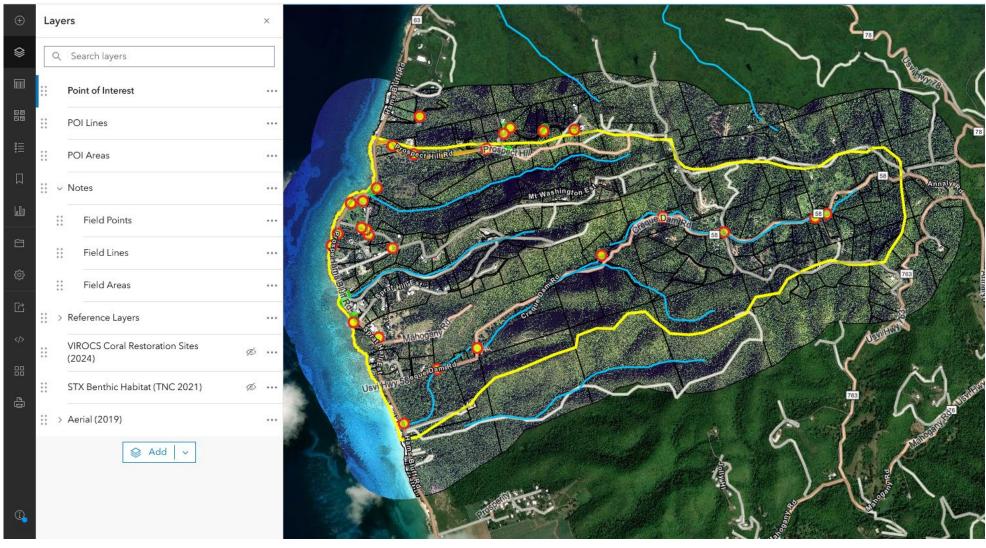
Figure 24. Public mapper showing locations of interest for field assessments

Figure 24 is a screen grab showing potential points of interest from the public watershed mapper.

Drainage Area	Sites of Interest
Butler Bay Gut	 Prospect Hill Rd. erosion and drainage issues. See maps and photos from Jodie Smolik with discussion of issue, ownership, specific locations, and suggestions. See concept design plan from Green Piece. Several pins on public mapper Confirm drainage boundary for watershed/subshed on northern slope Evaluate new development and land clearing activities Check out impoundment/dam just to north of watershed boundary (see mapper) Old well/catchment structures Hike gut if trail? Check out pond?
Central Gut	 Evaluate drainage conditions and structures along Mt Washington Estate Rd. Confirm subwatershed boundary to account for northward drainage onto main hwy Check out ponds, look at gut at easy access locations
Creque Dam Gut	 Evaluate culverts and other drainage infrastructure, including location where gut crosses over road 3 times (see public map) Confirm watershed boundary/high point up past Mt Victory Rd intersection Old plantation ruins in upper watershed Agricultural landscape and ponds Creque Dam Verify road surfacing and land cover changes from aerial imagery Hike gut trail down from farm (Brian D) Review Merwin forestry stewardship plan (Brian) Horse operations Extent and impact of new development activities and subdivision roads

Direct Drainage	 Prospect Hill Rd/Baobab Rd, Mahogany, and Spratt Hill Rds evaluation Confirm subwaters drainage boundaries Feather Leaf Inn drainage improvement plans from Island Design/VICS. Ryan discussed locations for stone in-ground catchment by tennis court and ideas to better control drainage across property; look at 3-4 sites marked by Ryan on mapper where drainage issues/solutions, include vetiver test plots Evaluate National Guard parking lot drainage improvements (how will we access this site)? Major culvert crossings under coastal HWY Shoreline stabilization at other locations along the shoreline?
